Manhole Inspection Summary

Manhole # S17W__027MH

Insp Date: **5/6/09 11:11 AM**

Location Address: **1601 SEXTON ST**

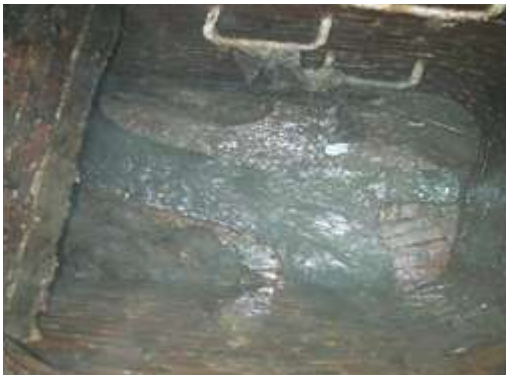
Miscellaneous

JUNCTION OFFSET - CONNECTIVITY
OF 12 OCLOCK NOT VISIBLE FROM
TOPVIEW PERSPECTIVE

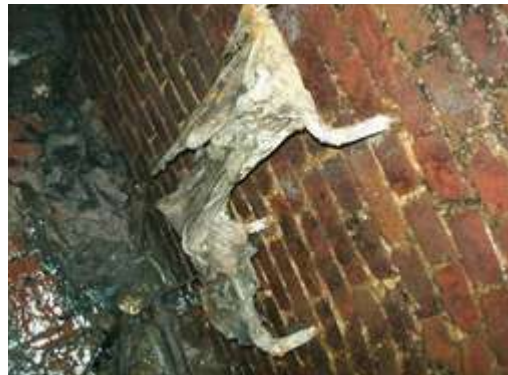
Defect 1

Count: **5** Missing: **0** ☒ **Corroded**

☒ **Evidence Of Surcharge** Depth: **7** (ft.) ☐ Active Surcharge Present

EVIDENCE OF SURCHARGE;
CORRODED STEPS

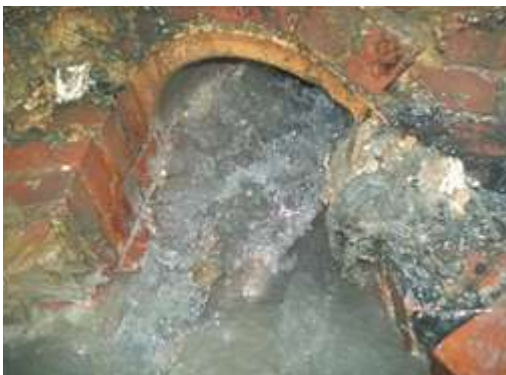
Defect 2

Condition: ☐ Sound ☐ Cracked ☐ Root Intrusion ☐ Deteriorated ☐ Leaks ☒ **Debris**

BENCH AND CHANNEL DEBRIS

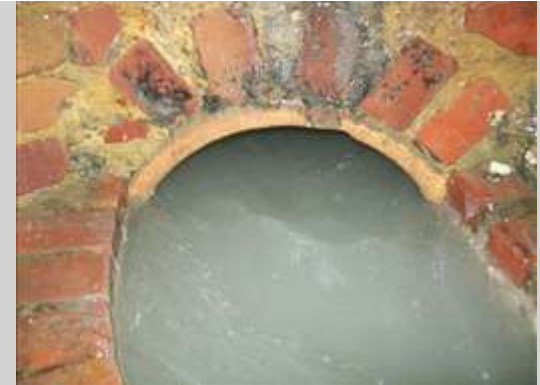
12 O'Clock Outflow

15 in. Circular Gravity Sewer
Pipe Out @ 12 O'Clock

Pipe Height: **15.6** (in.) Rod and Bar (Angled)
Pipe Material: **Clay** ☐ Pipe Lined
Invert Depth: **11.28** (ft.) Flow Characteristics: **Fast**
Deposits: ☒ None ☐ Mud ☐ ~~Sludgy~~ ☐ Debris ☐ Grease
Silt Depth: **0** (in.) Deposits Extent:
Infiltration: **None** Pipe Seal Cond: **Sound**

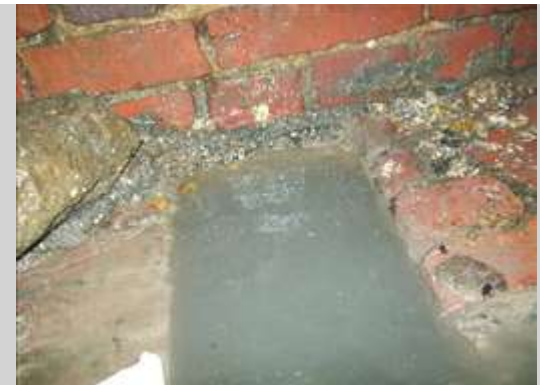
3 O'Clock Inflow

8 in. Circular Gravity Sewer
Pipe In @ 3 O'Clock

Pipe Height: **8.4** (in.) Rod and Bar (Angled)
Pipe Material: **Clay** ☐ Pipe Lined
Invert Depth: **11.00** (ft.) Flow Characteristics: **Slow**
Deposits: ☐ None ☐ Mud ☒ ~~Sludgy~~ ☐ Debris ☐ Grease
Silt Depth: **3** (in.) Deposits Extent: **Medium**
Infiltration: **None** Pipe Seal Cond: **Unknown**

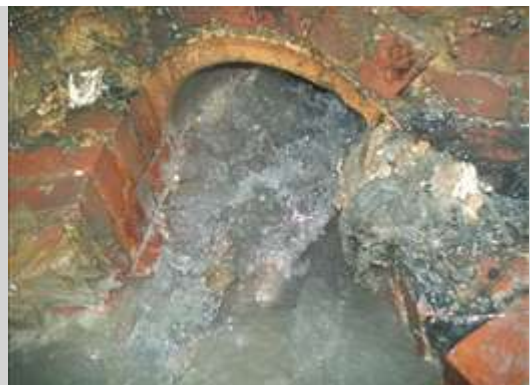
6 O'Clock Inflow

15 in. Circular Gravity Sewer
Pipe In @ 6 O'Clock

Deposits: ☐ None ☐ Mud ☒ **Sludge** ☐ Debris ☒ **Grease**

Silt Depth: **3** (in.) Deposits Extent: **Medium**
